SAVVY MAINTENANCE / OPINION

# Can't sign it off?

## Can a mechanic who works on your airplane refuse to put it back together?

BY MIKE BUSCH

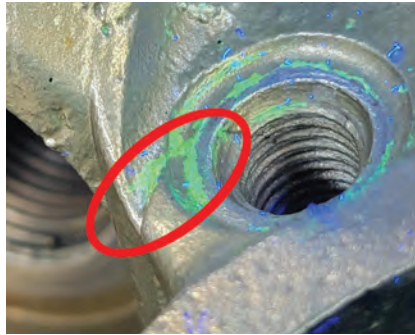
Fluorescent dye penetrant inspection. This might or might not be a crack. If it is a crack, it doesn't present a safety issue.

Tom asked the DOM why the shop was concerned about cylinder head cracks. The shop cited Continental service bulletin MSB09-1B, which dealt with head cracks between the top spark plug and fuel nozzle bosses. The DOM insisted the cylinders with cracked heads had to be replaced. The shop sent Tom some photographs showing fluorescent dye penetrant inspection results of several cylinders. Some of those photos revealed nothing of interest, but a couple showed features that could be cracks.

bulletin applied to only 300 cylinders identified by lot number. Finally, head cracks in this area are common and have never caused any sort of in-flight failure, incident, or accident.

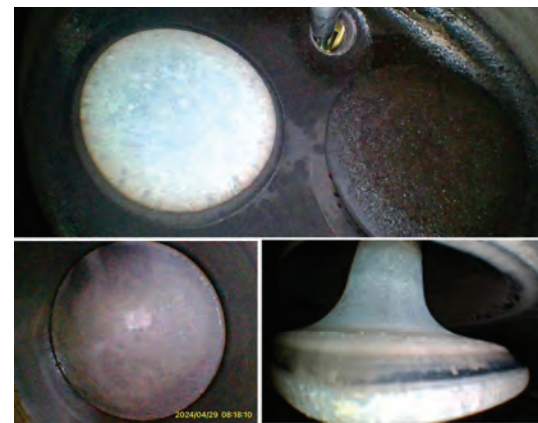
Tom reviewed these borescope images and asked several other members of the Savvy team to do so. All of us agreed that the valves looked perfectly normal. Tom also obtained the engine monitor data for the incident flight and asked Savvy data analyst Stephanie Schledorn, an A&P/IA, to review it. Stephanie reported that CHT number 3 never exceeded 429 degrees F—not even close to Continental's redline of 460 degrees F—and that the EGT had been stable, suggesting that no detonation had occurred in the cylinder.

Exhaust deposits on the exhaust valve can be any combination of brown, red, orange, yellow, white, and even green. The color isn't important. What's important is whether the deposit pattern appears symmetrical. Tom sent the shop a copy of the AOPA poster "Anatomy of a Valve Failure" to help them understand how to distinguish normal and abnormal exhaust valves, and why we were convinced that Mark's number 2 exhaust valve looked normal.

Borecope images of the number 2 exhaust valve appeared perfectly normal.
