MIKE BUSCH

Cam Distress

When your engine finally needs to be overhauled, the most likely cause will be corrosion-induced distress to the cam lobes

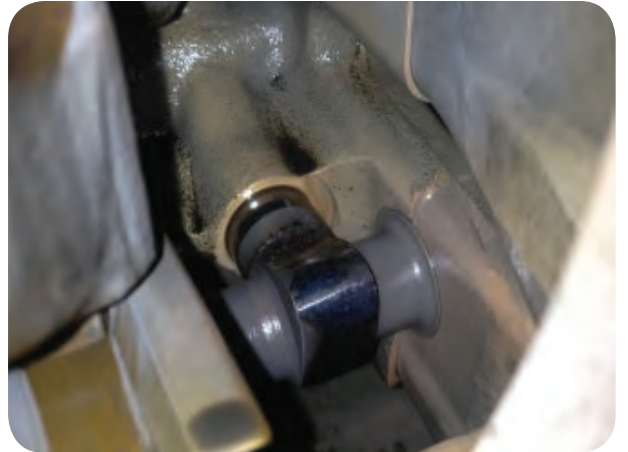
Figure 1—When the cylinder came off and the IA looked at the cam lobe, he told the owner, “Your engine is dead!”

The owner attached some photographs of his Continental O-470-U engine showing a cam lobe in questionable condition (see Figure 1) and a severely spalled lifter (see Figure 2).

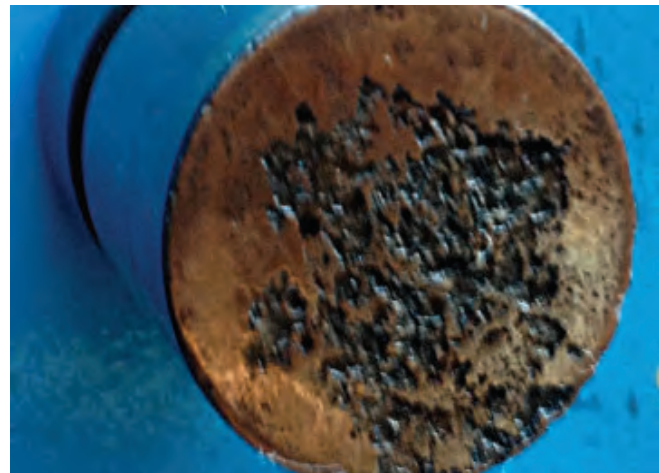
It doesn’t take an engine expert to see that the lifter (Figure 2) is in horrible shape. Fortunately, this is no big deal in

Figure 2—This lifter is severely spalled and clearly unairworthy. But on big-bore Continental engines, lifters are cheap and easy to replace.

Continental 360-, 470-, 520- or 550-series engines. Because these engines use “barrel-style” lifters that can be easily removed from the outside of the crankcase, replacing damaged lifters on these engines is easy and cheap. In fact, if you use PMA-approved lifters from Superior Air Parts, they only cost about \$75 each. (If you buy them from Continental, the cost is almost three times as much.)

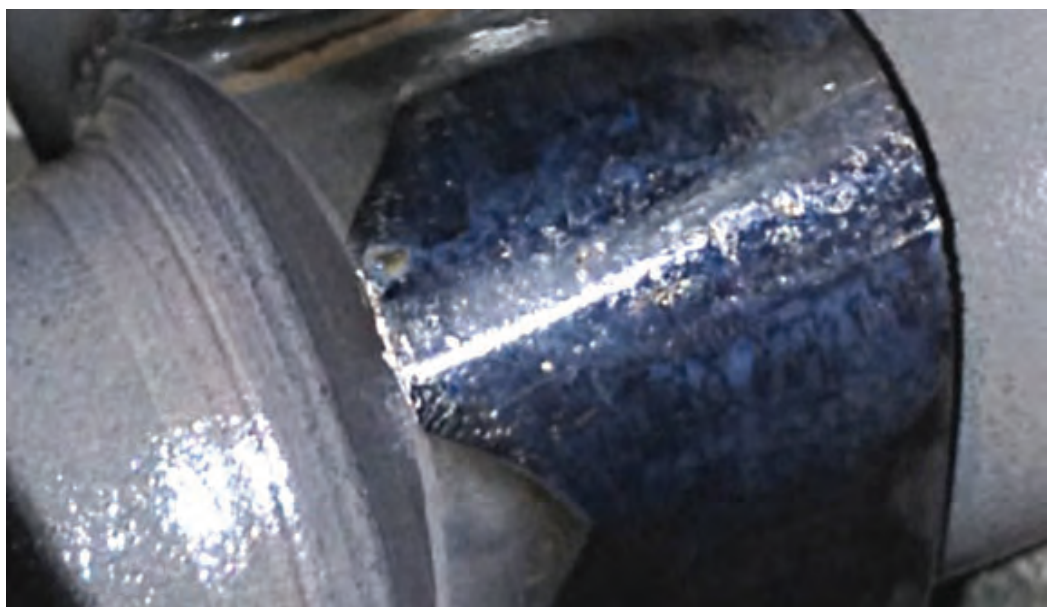
The real concern here is not the lifters but the cam. If the cam is unairworthy, then a teardown becomes unavoidable. When I zoomed in on the owner-supplied photo of the cam lobe to take a closer look at the questionable lobe (see Figure 3), it was obvious that it was exhibiting clear signs of distress.

A detailed review of SID05-1 makes it clear that Continental considers a certain amount of pitting of the cam lobe toe area to be acceptable. So long as the pits aren't deep enough to penetrate the case-hardened (carburized) outer layer of the cam lobe (which is about 15 thousandths of an inch thick), there is little risk of accelerated deterioration. The document goes on to say, “For minor distress, the camshaft may be continued in service and re-examined upon the accumulation of 100 hours operation or 12 months, whichever occurs first.”

Figure 3—This close-up of the questionable cam lobe suggested that the distress is still minor and the engine could remain in service with 100-hour lifter inspections.

Consequently, when in doubt, I see no risk in replacing the spalled lifter(s) and flying the engine another 100 hours. The worst that could happen is that the pitted cam lobe will tear up the new \$75 lifter, and you'll wind up having bought an additional 100 hours before tearing down the engine. On the other hand, the new lifter might wind up surviving that 100 hours unscathed, in which case you dodged the bullet and may be able to extend the life of the engine for hundreds of additional hours.

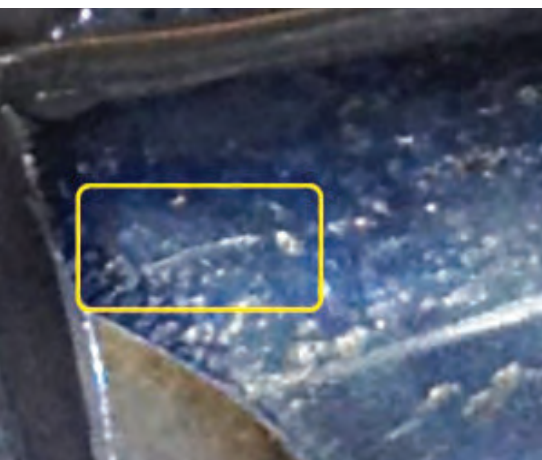
Figure 4—This close-up of the cam lobe at a slightly different angle reveals what might possibly be a surface crack—or perhaps just a piece of lint from a shop rag. The only way to know for sure is to probe it with a sharp pick.

On the other hand, SID05-1 indicates that Continental is very concerned about cracks (as opposed to pits) in the cam lobe surface: "If the visual inspection indicates the presence of crack like features in the surface along the cam lobe apex, proceed as follows: Using a sharp pick, move the point over the nose. If a crack like feature has any depth, the pick will catch in the groove or pits. If no positive indication of a crack is felt, no further action is required. If an indentation is present, the cam must be

This guidance also makes sense, because a crack in the cam lobe could result in the lobe coming apart fairly rapidly. When I studied a different photo of the questionable cam lobe under high magnification (see Figure 4), I spotted a suspicious anomaly in the photograph that could conceivably be a crack—or it might just be a piece of lint from a shop rag. The only way to know for sure would be to probe the lobe with a sharp pick and see whether the alleged crack has any significant depth to it. If it turns out to be an actual crack with significant depth, then I would reluctantly have to agree with the IA’s doomsday prognosis.

Although SID05-1 doesn’t mention this, I suggested to the owner that before performing the “sharp pick inspection” of the cam lobe, it would be a good idea to polish the cam lobe with some crocus cloth or very fine emery cloth to remove rough edges from the minor distress features. This is a trick that I learned from Bob Moseley, who served as Continental’s central region field representative for five years and possessed encyclopedic knowledge of these engines and their ailments. (Bob passed away suddenly and unexpectedly

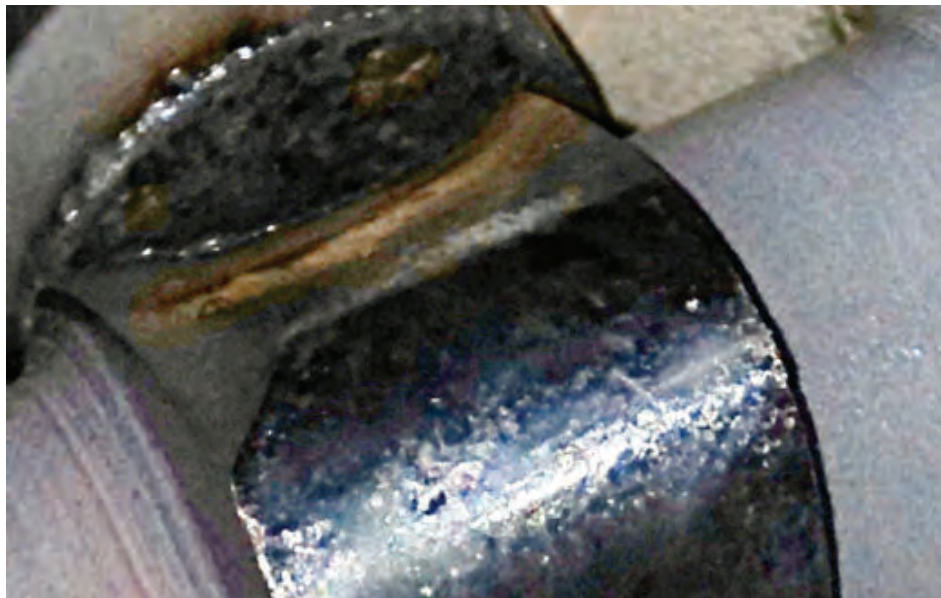
Figure 5—A higher-resolution image of the cam lobe, taken with a better camera and with better lighting, shows the cam lobe to be in worse shape than it originally appeared.

I genuinely hoped that the owner would be able to get another year or three out of his engine—I just hate to see an engine torn down before its time—but alas that was not to be. Closer inspection of the cam lobe revealed it to be in substantially worse shape than it initially appeared. (See Figure 5.) At the end of the day—and after the IA brought in a colleague to inspect the cam lobe and render a second opinion—it became clear that this cam lobe had progressed beyond the point of “minor distress.” The owner ultimately decided to bite the bullet and order a factory rebuilt engine.
