SAVVY MAINTENANCE / OPINION

Unaffordable, unavailable

As the GA fleet ages, replacement parts are getting harder to come by

BY MIKE BUSCH

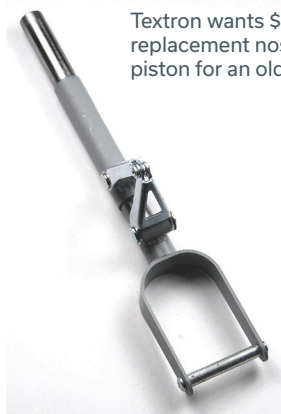
RECENTLY, A CLIENT with an older Cessna 182 Skylane reported that his nose landing gear strut was leaking fluid and repeatedly going flat. Inspection revealed that the original chrome strut piston had become badly pitted and was tearing up the nose strut seals. The owner's shop checked the Textron Aviation parts system and found that they had one replacement strut piston in stock, and clearly, they were extremely proud of it. The price: \$9,200. That's nearly 10 percent of the fair market value of the whole airplane. Yikes!

Textron wants \$9,200 for a replacement nose gear strut piston for an older Skylane.

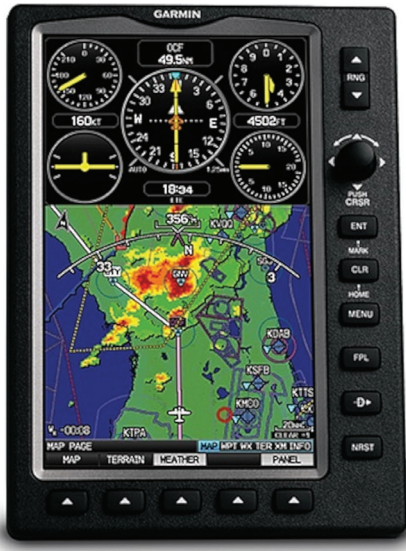
Garmin no longer supports the GPSMAP 696.

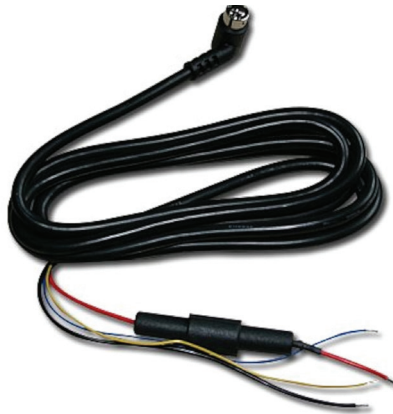
At first, I thought that perhaps the cable had developed a bad spot from repeated flexing because of yoke movement. Or that perhaps the socket in the 696 had become worn or corroded. But after a couple of hours of meticulous troubleshooting and fault isolation, I concluded the problem lay in the right-angle plug at the end of the cable where the wires made a sharp 90-degree bend. Since the plug was a molded assembly, there was no way of opening it up to repair it without destroying the plug—don't ask me how I know this.

The author couldn't find a replacement power/data cable for his 696 anywhere (even eBay).

The most obvious solution would be to replace the power/data cable. I located the part number for the cable (010-11206-15) but found that Garmin had discontinued this item many years ago. A search of avionics distributors and aviation parts supply houses came up dry. I found some ads on eBay for what purported to be 696 power/data cables, but careful examination of the accompanying photos revealed that they had the wrong type of connectors and were clearly not compatible with the 696.

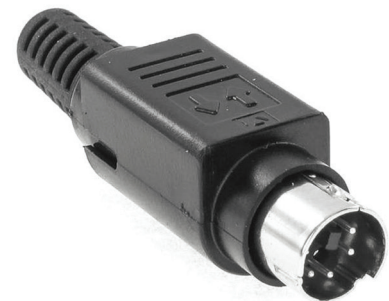
The author found this Kycon KPPX-4P plug that fit the socket on the 696.

Fortunately, I still had one more KPPX-4P kit left, and the third attempt proved the charm. The result of my efforts was two feet of four-wire cable with a KPPX-4P on one end and bare wires on the other end. When I plugged the Kycon connector into my 696 and connected my 24-volt power supply to the red and black wires, the 696 powered up. Yes!

The next day, I drove to my hangar with my 696 and its new two-foot dongle in tow. I chopped the defective right-angle plug off the end of the Garmin cable and carefully attached the Garmin cable to the new

dongle, using crimp splices and shrink-wrap tubing. I then tidied up and secured the wire bundle from the 696 to all the other stuff connected to it using tie-wraps and Adel clamps.

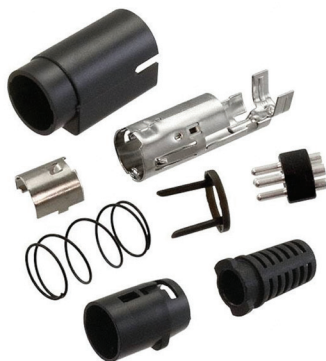
I excitedly opened the package and was surprised when I found what appeared to be a build-it-yourself connector kit consisting of eight (count 'em) separate components. One of them was a tiny plastic thingy with four pins, which I quickly determined matched the configuration of the four-pin socket on the 696. Another appeared to be a round metal barrel that appeared to fit in into the 696 socket. Yet another looked like a cable strain-relief fitting, and the remaining four components included a spring plus some plastic and metal thingies whose purposes were certainly not obvious. Naturally, no instructions were packed with the connector kit.

The Kycon connector came as a kit with eight tiny pieces and no assembly instructions.
