SAVVY MAINTENANCE / OPINION

Distrust and verify

The perils of trying to fix a problem you haven't seen for yourself

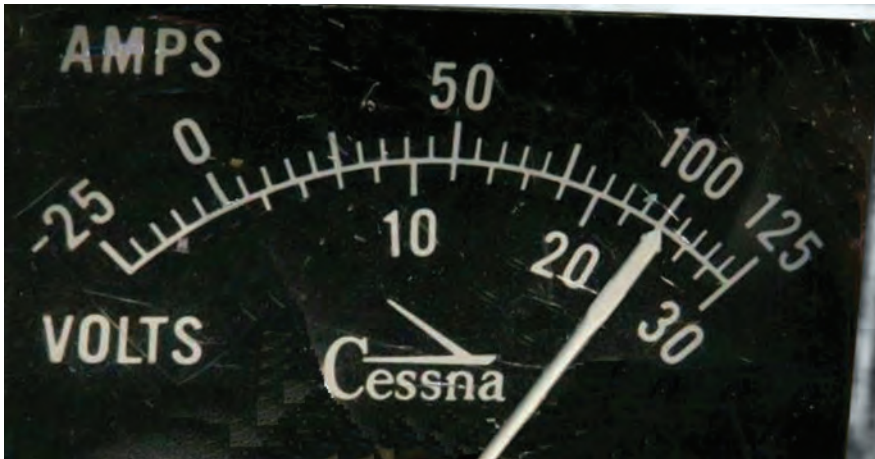
Understanding how the Cessna 310 volt-amp indicator works and what it indicates are key to diagnosing any potential problems.

He was referring to the small analog meter located on the instrument panel behind the engine control quadrant. Next to the meter is a four-position rotary switch with positions labeled L. Alt, R. Alt, Bat, and Volts. Depending on the switch position, the meter shows the current output of the left or right alternator, the current into or out of the battery, or the main bus voltage. (I have the same system in my own airplane.)

"Your alternators are supposed to share the load about equally," I explained. "To do this, the regulators for the two alternators talk to one another via a wire that connects them together. This is called 'paralleling.'"

"The regulators are adjustable, and they are supposed to be adjusted so that the two alternators share the load," I continued. "Yours are obviously out of adjustment, causing the left alternator to do all the work and the right alternator to loaf along at zero output. That's why you're seeing zero on the meter."

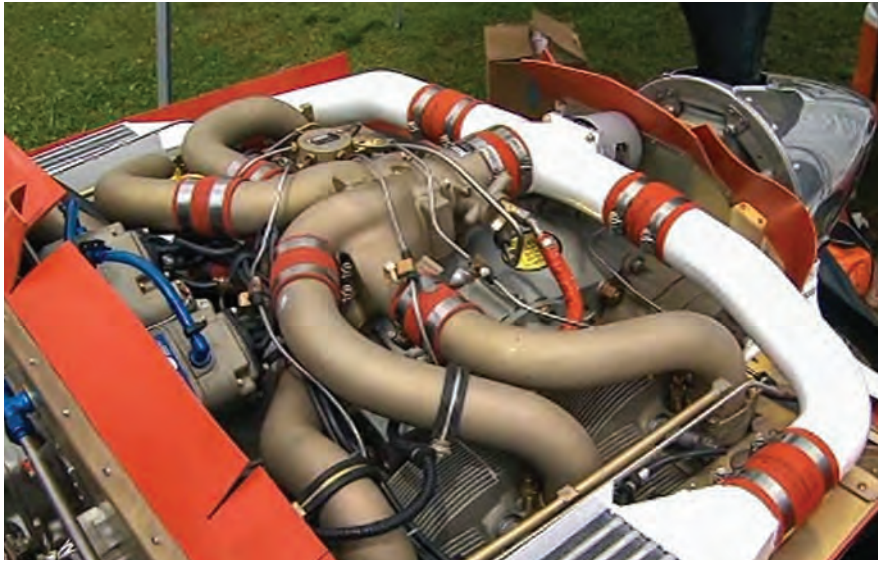
Cirrus SR22 Turbo powerplant.

The problem with the engine became immediately obvious: The distributor gear in the right magneto had shed some gear teeth and was not rotating. This is a well-known failure mode of these magnetos, and results in spark plugs firing at random times in random cylinders. The result is always an engine that runs change-of-underwear rough, and sometimes causes cylinder damage due to preignition. Fortunately, in this case, the pilot’s swift power reduction prevented such damage from occurring.
